*Original Research Article*

## **An Enforcing Resilience of Steep-slope Citrus Orchards Against Slope Failure Caused by Torrential Rain**

**Tomoki Izumi\***, Naoyuki Yamashita, Noriyuki Kobayashi

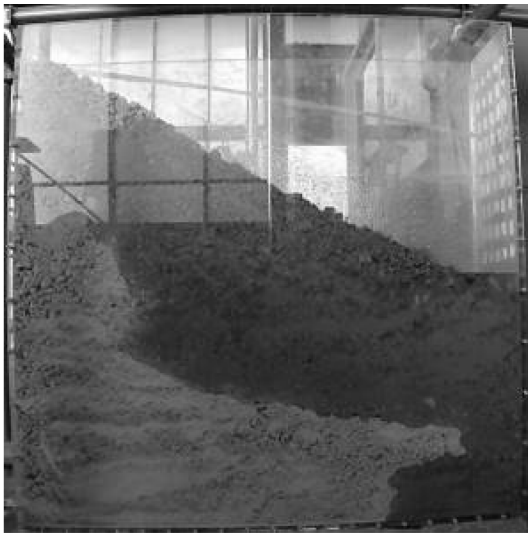
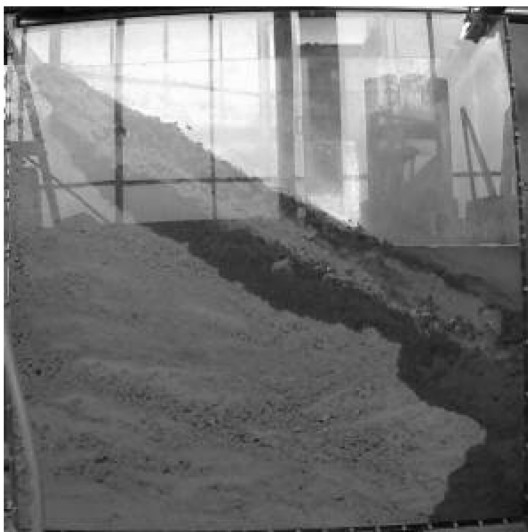
(a) Case 1

(b) Case 2

(c) Case 3

(d) Case 4

Figure 4. Rainfall infiltration 7,200 seconds (2 hours) later

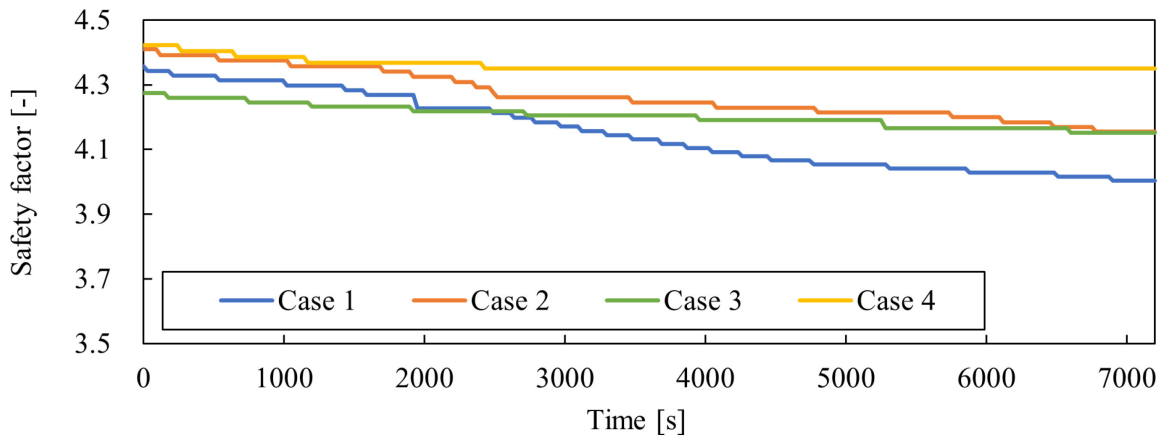
Figure 6 shows the temporal change of the infiltration depth in each experimental case. Figure 7 shows the temporal change of the safety factor at  $Z = 50$  cm. From Figure 6, it is found that the larger the clay mixing ratio, the smaller the water depth due to rainfall infiltration. In fact, the infiltration depth at 7,200 seconds later was 0.31 m in Case 1, while it was 0.06 m in Case 5. From Figure 7, it is found that the slope safety factor decreases with increasing clay mixing ratio due to the suppression of rainfall infiltration. Case 3 had the lowest safety factor at the beginning of the experiment, but the safety factor was slightly decreased with time and then equivalent to that of Case 2 after 7,200 seconds.

Figure 7. Temporal change of the safety factor at  $Z = 50$  cm

Thus, from the perspective of slope stability, lower permeability results in less rainfall infiltration and a more stable slope. Conversely, from the perspective of citrus cultivation, lower permeability results in reduced water availability for citrus growth. One day after the infiltration experiment, the rainfall infiltration below the improved soil layer was observed. It was confirmed that in Cases 1 to 3, the rainfall infiltrated to the bottom of the soil tank. Since the maximum root zone of citrus trees is at most 50 cm, it is considered that the required amount of water could be secured in these cases. Therefore, the results of this experiment suggest that the optimal clay content ratio for both ensuring slope stability and implementing citrus cultivation is between 20% and 50%. However, further study is necessary to determine the appropriate clay mixing ratio to ensure the required amount of water in case of lower rainfall intensity than in this experiment.
